Rigging, Dismantling & Demolition News from R. BAKER & SON

January 2022 | Volume 15 Issue 1

R. Baker & Son Completes Fulton Fish Market Dismantling Project

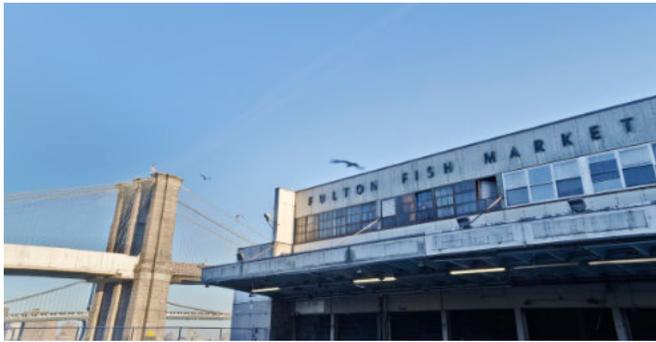
R. Baker & Son recently completed dismantling of the historic Fulton Fish Market on the East River waterfront in Lower Manhattan.

The project called for removal of the three-story, 50,000 sq. ft. structure which stood on the base of Pier 17 on South Street. Due to the significantly deteriorated pier, all work was required to be performed utilizing primarily manual means and methods, with zero loading on the majority of the pier slab. Several creative project innovations were required to complete this task. For the transite panel abatement, a combination of swing stage scaffolding and manlifts stationed on floating barges were utilized to unbolt and lower panels into the building envelope.

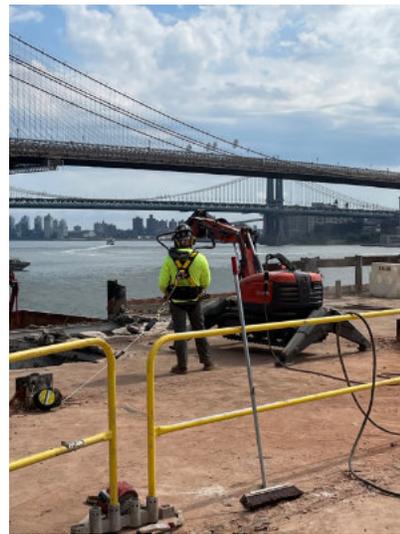
Following abatement, R. Baker & Son mobilized a 100-ton conventional crane with barge, accompanied by a hopper barge, to perform the dismantling and removal of the superstructure and building debris. All interior upper levels were dismantled using a combination of small-track skid steer loaders and robotic breaking equipment. Debris was removed across upper building slabs to skip pans that were attached to the conventional barge-mounted crane and lowered into awaiting hopper barges. All crane activities had to be timed to occur when no ferries

or water taxis were passing as their wakes could rock the barges and cause crane loads to swing. Upon completion of the dismantling, all structural steel required manual hand torch cutting and sizing for removal to awaiting barges in a similar manner to the construction debris. Work progressed on a bay-by-bay, floor-by-floor basis, with zero disturbance to the concrete pier slab.
